# NEWSLETTER

Vol. 31 – No. 1  
January – February 2019

## Repairing a 74490 Turnout Motor

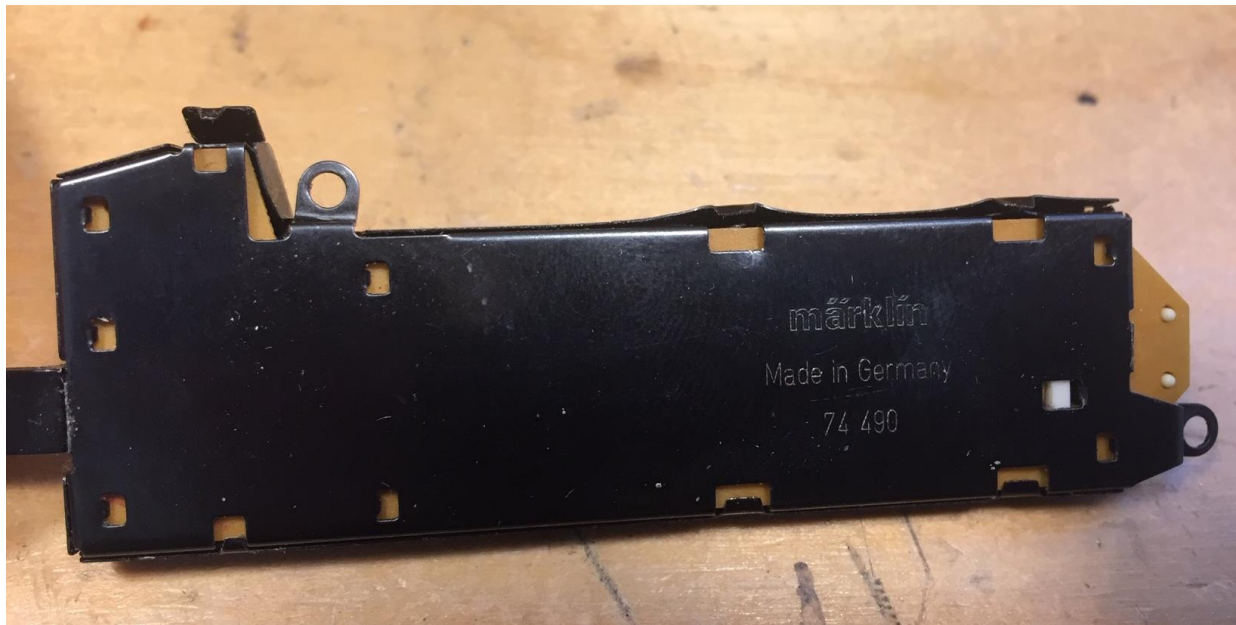
Gently pry up the three tabs on the long edge that is not straight (Fig.1). If you like, you can pry the other three, but I have found if I leave them alone, they act as a hinge and the unit opens like a clamshell.

Fig. 1 – Open tab locks on the side that is not straight

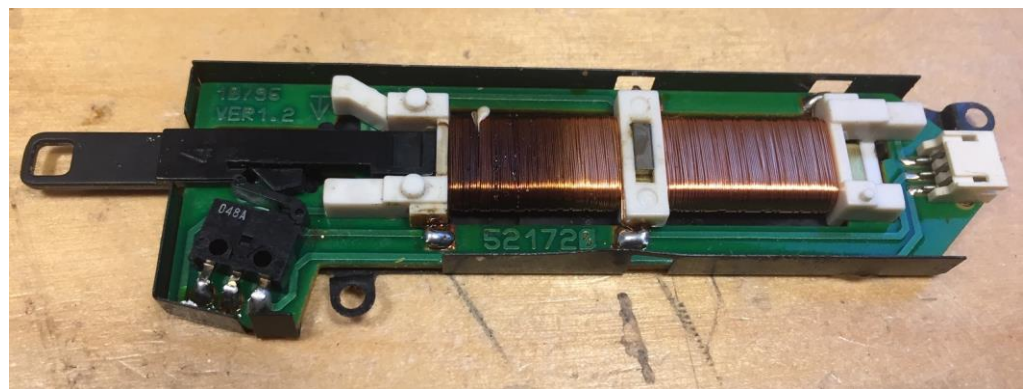
Once the cover is off, inspect the field magnet windings. If the windings are heat-damaged, then the motor is no good and ready to be recycled as e-waste (Fig.2). This motor has overheated and that is noticeable by the darker field magnet windings (Fig.3). In fact, it has been heated so much, the plunger has melted a little and does not slide smoothly any more. This motor is e-waste now.

Fig. 2 – Damaged field magnet

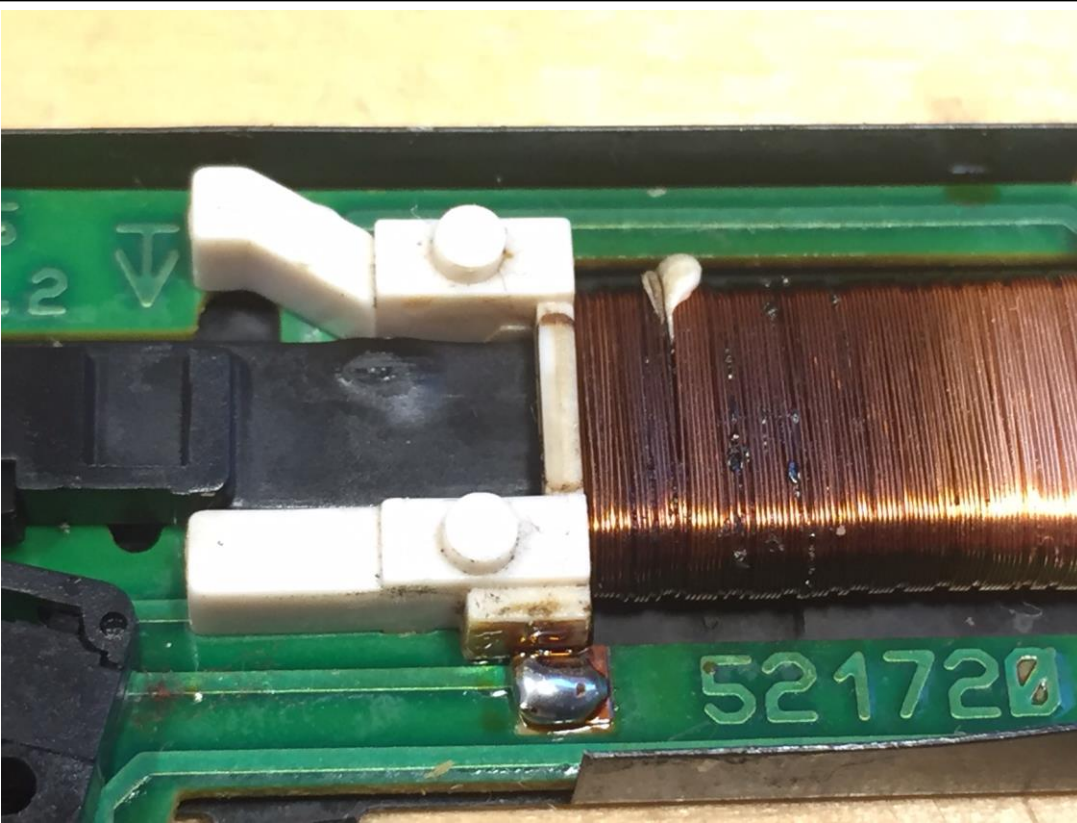
Fig. 3 – Burnt field coil and melted plunger

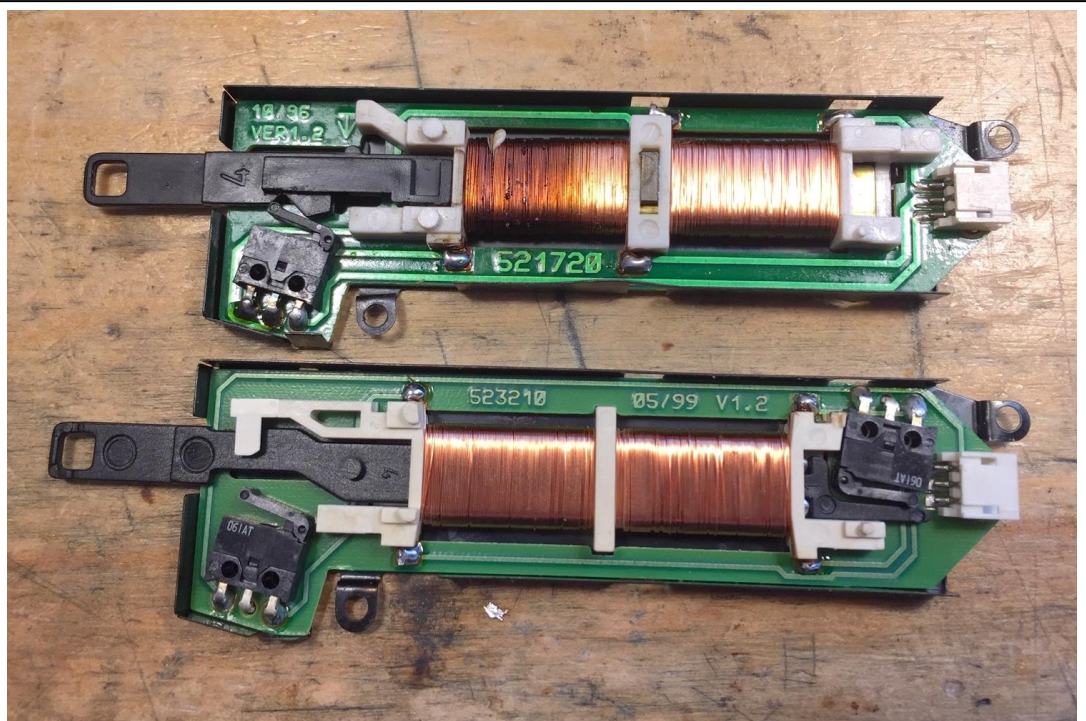
Fortunately, I have another motor as a candidate. The first turnout motor looks to be a very early version, whereas the second one is a later version. This later version has a limit switch at each end of the plunger throw (Fig 4). Once the plunger is at the end of its throw, this switch cuts off the power to the field magnet so the windings won't overheat. The first motor only has a single limit switch, which has failed and caused the coil to overheat.

Fig. 4 – Lower unit has two limit switches

More often than not, this limit switch is the problem. It can occasionally fail, and then the turnout will only throw in one direction. The solution is to bypass the limit switch.

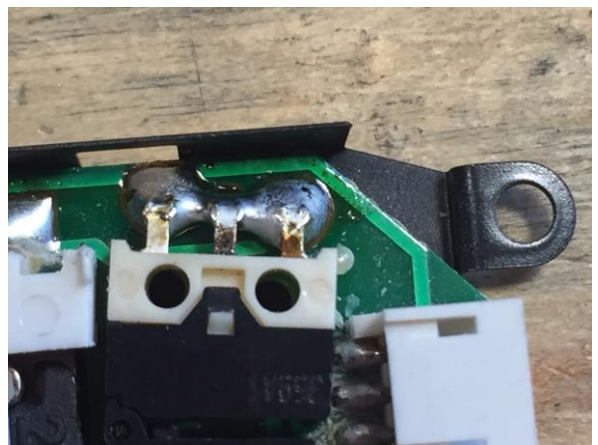
Fig. 5 – By-passed limit switch

Since the turnout motor is already broken, I took my soldering iron and bridged the limit switch contacts together effectively bypassing it (Fig. 5).

Once this is done, I re-assembled the turnout motor and tested it. It worked just like new, confirming that a limit switch (or both) was the problem.

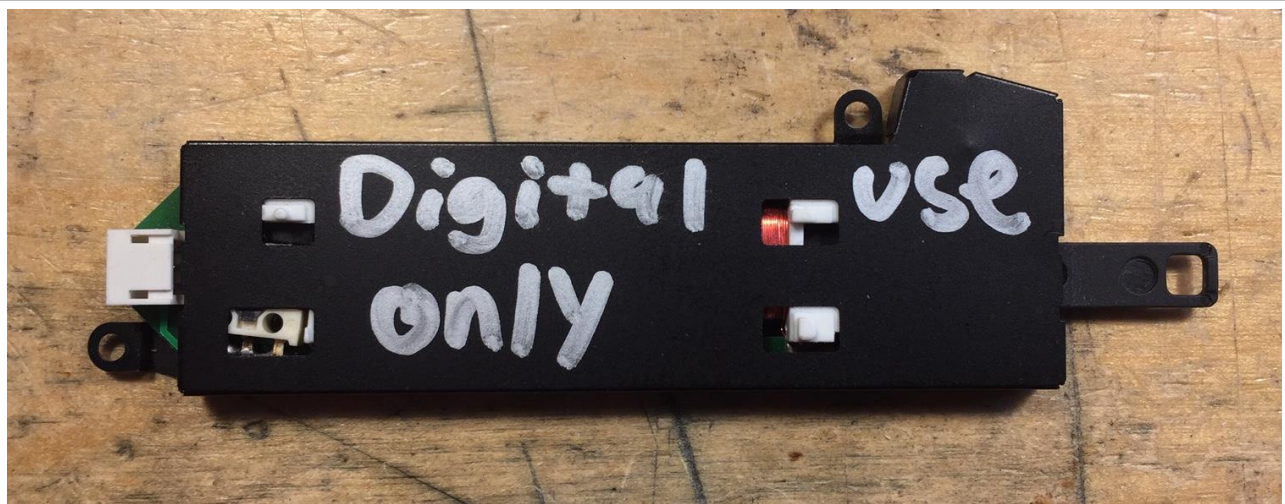
Fig. 6 – Designation for repaired turnout motor

Now that the repair is done, I can only use this turnout motor in “Digital Operation.” This is because the limit switch is bypassed and if I use an analog control box, there is a chance of pushing the button too long and overheating the field coil inside, making the motor e-waste. A digital controller will send a pulse of about 300ms, which is far too short for any over-heating. So, the very last thing I did was to mark the outside cover designating that this motor has been fixed (Fig.6).
