# NEWSLETTER

Vol. 31 – No. 1  
January – February 2019

## Repairing a 74490 Turnout Motor

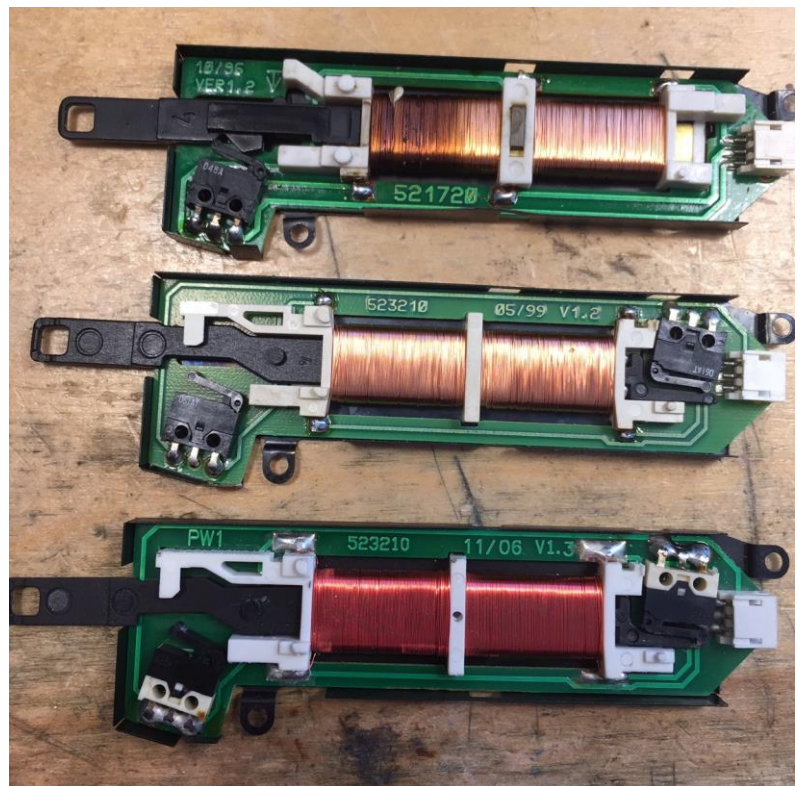
As it turns out, I have three different versions of the circuit board for the 74990 turnout motor. I am sure that there are a few more, but I have not come across them (Fig.7).

Fig. 7 – Three types of circuit board for 74990
